**REPORT ON THE HISTORIC PRESERVATION ASPECTS  
OF THE REHABILITATION OF WINDOWS  
AT THE BELLEVUE AVENUE BRANCH LIBRARY  
TOWNSHIP OF MONTCLAIR, ESSEX COUNTY, NEW JERSEY 07043**

**MARY DELANEY KRUGMAN ASSOCIATES, INC.**

April 2019

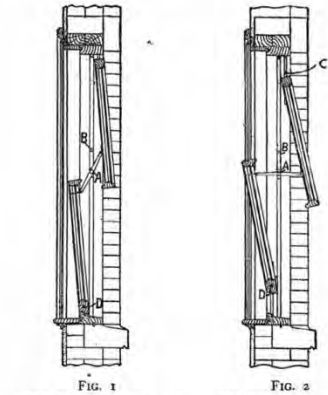
By reference to the illustrations it will be seen that the two sashes are connected by a lever (A) pivoted in the centre, fixed on the parting bead (B) and attached to both sashes so that they exactly counter-balance. Thumb bolts are fitted on each side at the top of the upper sash and the bottom of the lower sash, and travel in a groove (C) made in the window frame. These bolts serve as guide pins to keep the sashes in the normal position, and when withdrawn from the groove allow the sashes to be reversed and brought inward for cleaning (Fig. 6). When the lower sash is raised, the upper sash swings outward and is lowered, owing to the lever connection (Figs. 2 and 5). The window can be opened as wide at top and bottom as the ordinary sliding sash window (Fig. 4).

FIG. 1 Window Sashes Closed at bottom but slightly open at top and centre, or meeting rails. Ventilation without direct draught

FIG. 2 Window Sashes Open at top, bottom and centre, which illustrates full ventilation

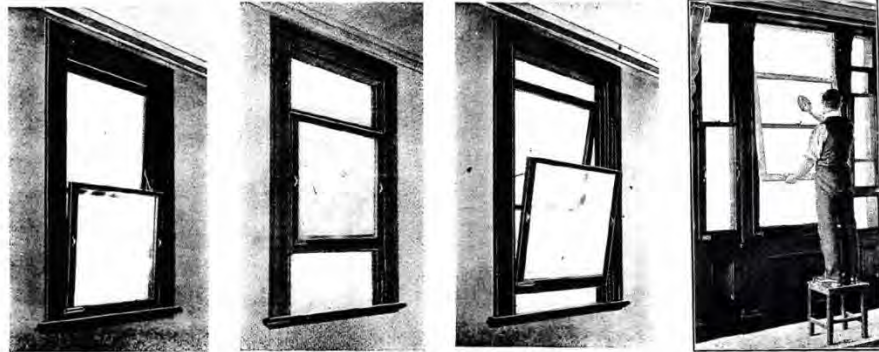
FIG. 3 Window Partly Opened in the middle and top and bolted at the bottom, thus making it secure against intruders, though giving perfect ventilation

FIG. 4 Window Fully Opened

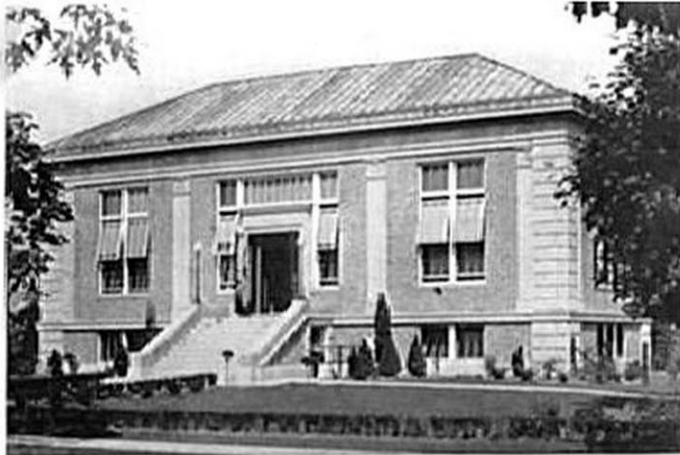
**H-1**

Bellevue Avenue Branch Library ca. 1920, looking NW, showing original color scheme. Austral windows are shown in open position.

The exteriors of the Austral windows at the Bellevue Branch Library were in a deteriorated state throughout. According to anecdotal evidence, the sash and window frames had been painted with “robin’s egg blue” paint for some decades, which differed from the original cream color (see Appendix C: Photo H-1 – H-3 (original color); Photos 1 - 6 (showing later blue color).

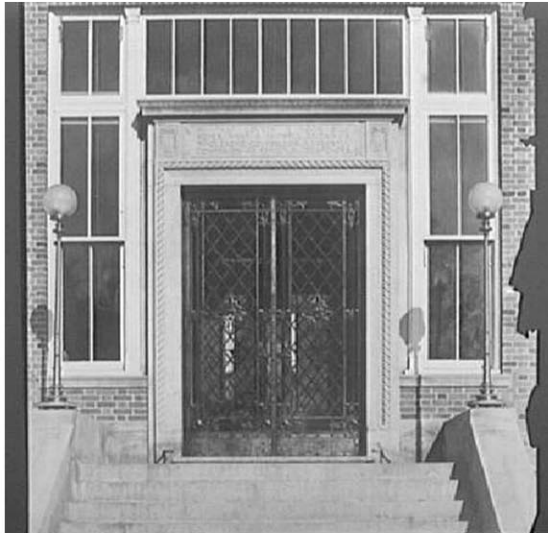
**H-2**

Main entrance on Bellevue Avenue ca. 1915, looking N. The Austral lever arms on lower sash are shown painted to match sash color.

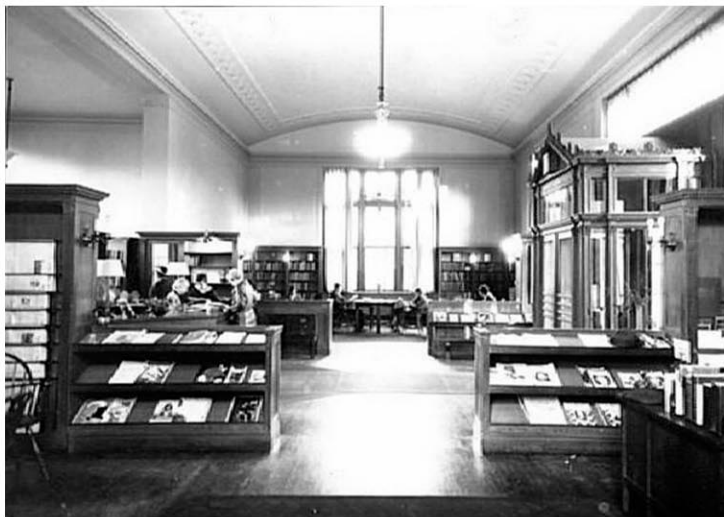
**H-3**

Reading room of the Bellevue Branch Library ca. 1920, looking E.

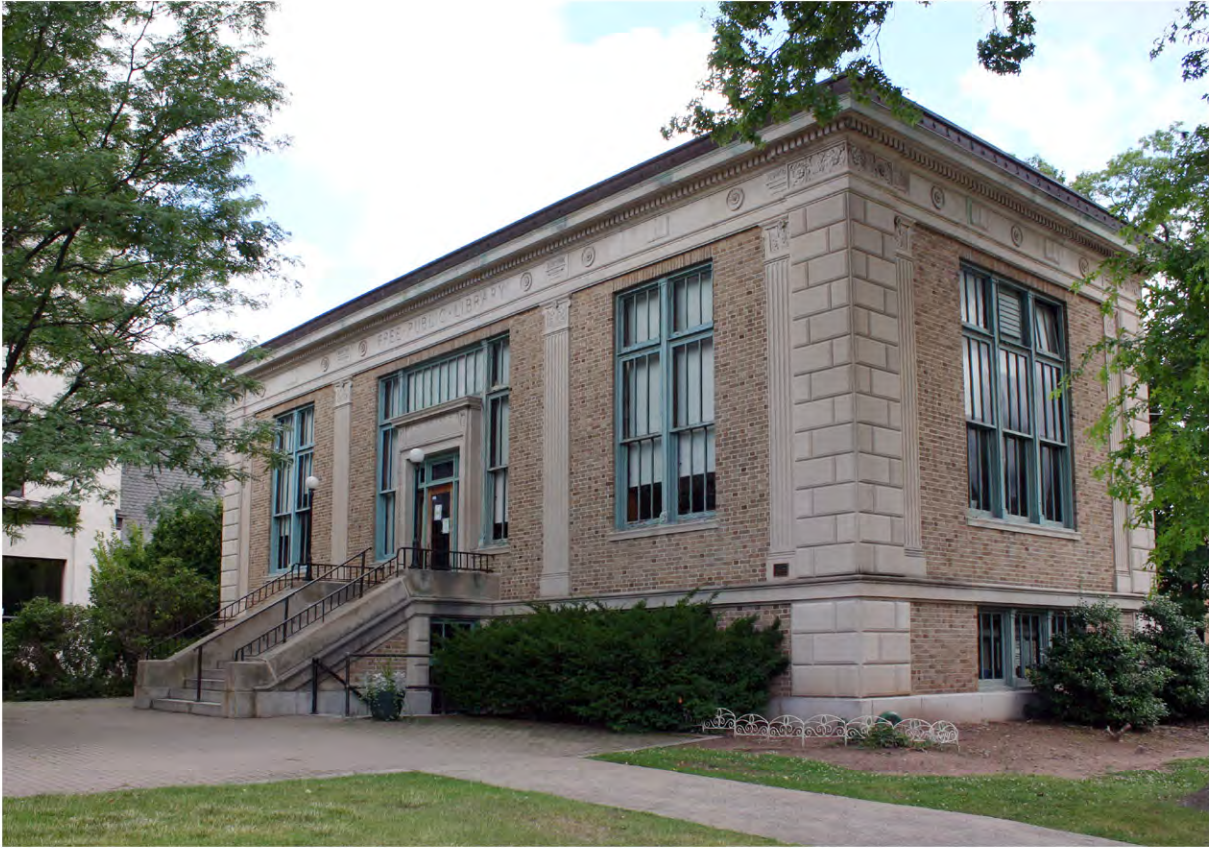
1

Bellevue Avenue Branch Library (BAB) in 2016, looking NW .

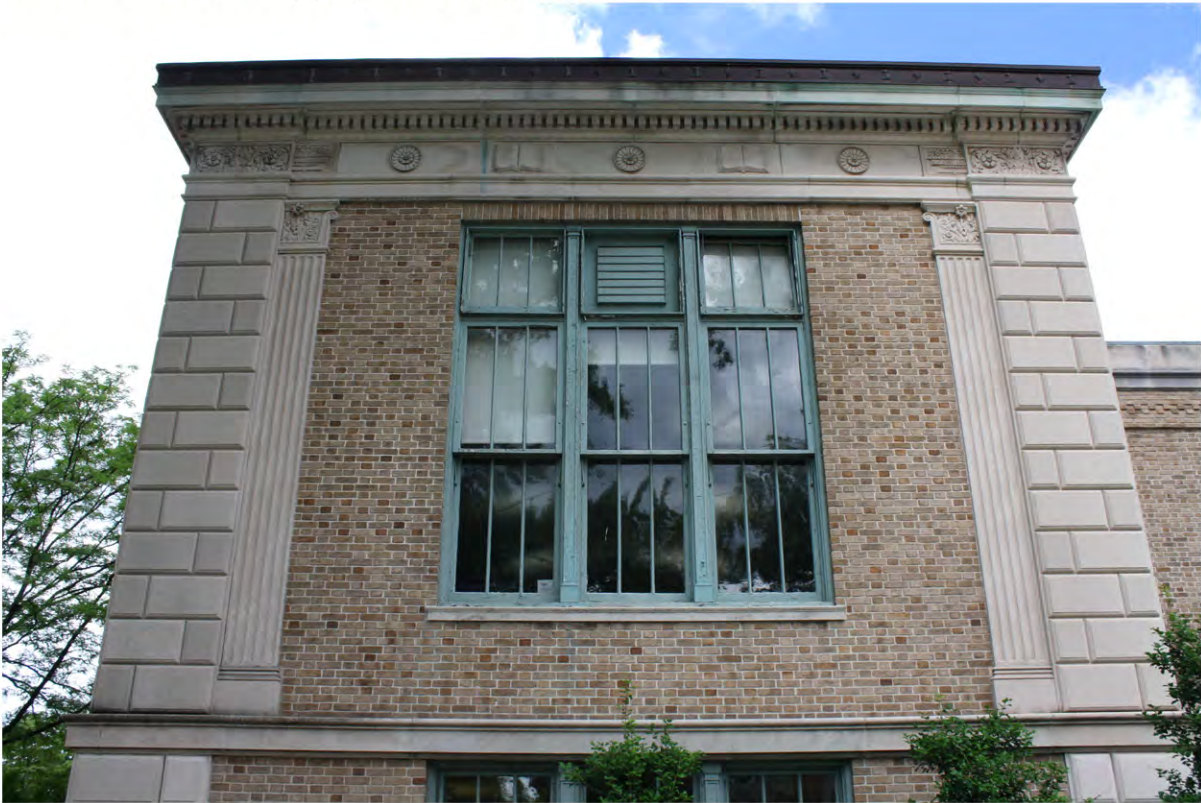
East facade of BAB in 2016, looking W.

Only one wood sash was entirely replaced: the middle transom on the east façade due to the removal of a later-installed fan on the east elevation (see Appendix C: Photo 2 (before) and Photo 16 (after)).

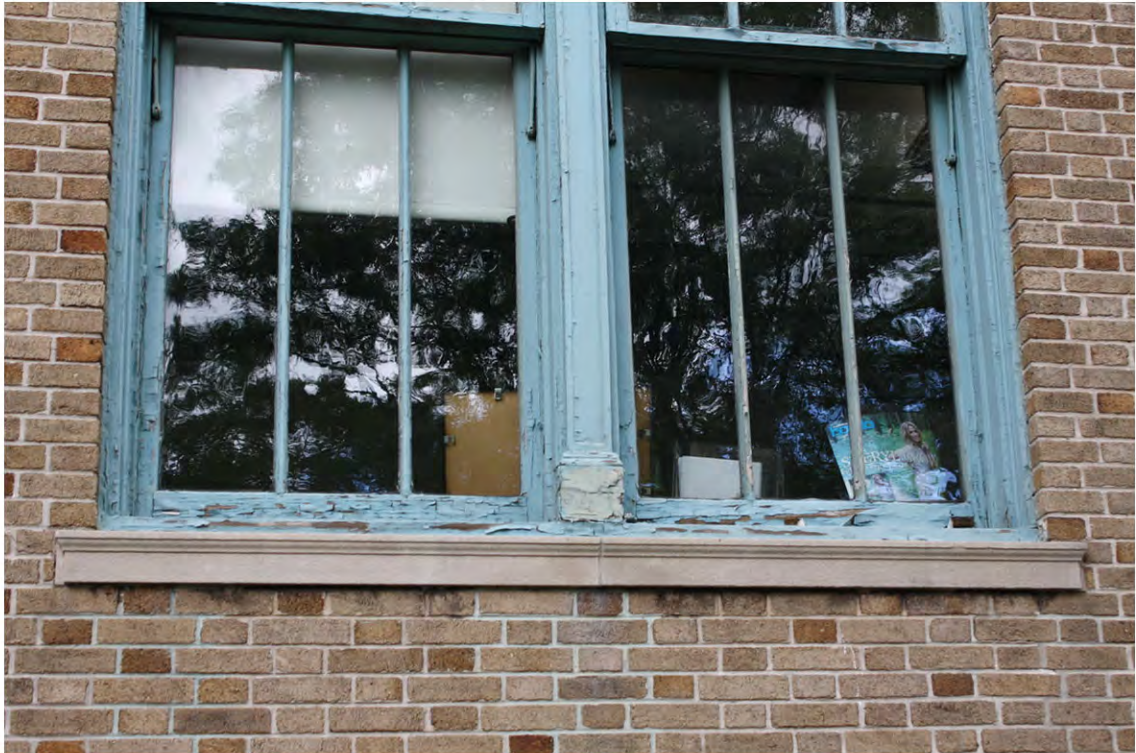
**3**

Library windows on south facade in 2016, looking N, showing level of deterioration.

The exterior of the windows was suffering from failing paint and deterioration due to weathering. The interior of the sash was finished with a stain and/or varnish, which appeared dried out and, in some locations, had suffered from water damage due to interior condensation. The lever arms that operated the window sash had been painted along with the sashes and were no long operable. The transoms above the Austral windows were also painted shut, and the sash chains were either missing or covered with paint so that they did not swing freely (see Appendix C: Photos 3 through 5).

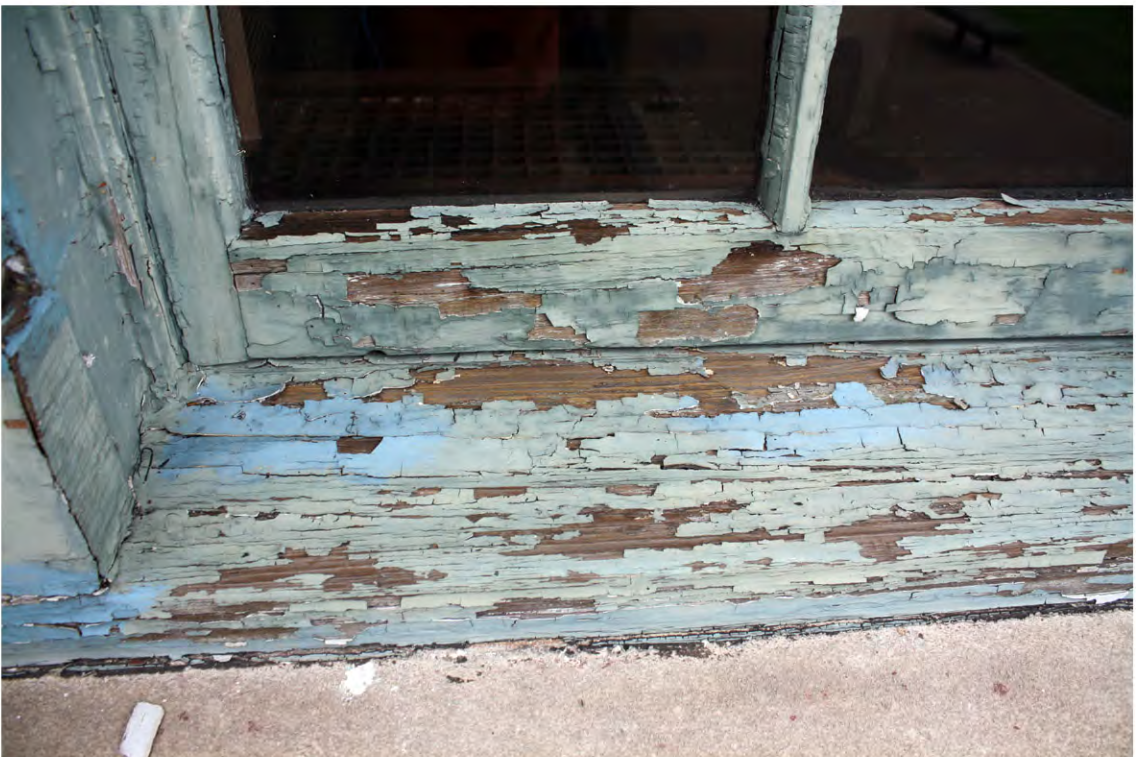
**4**

Detail of deterioration on sill at main facade, looking N. .

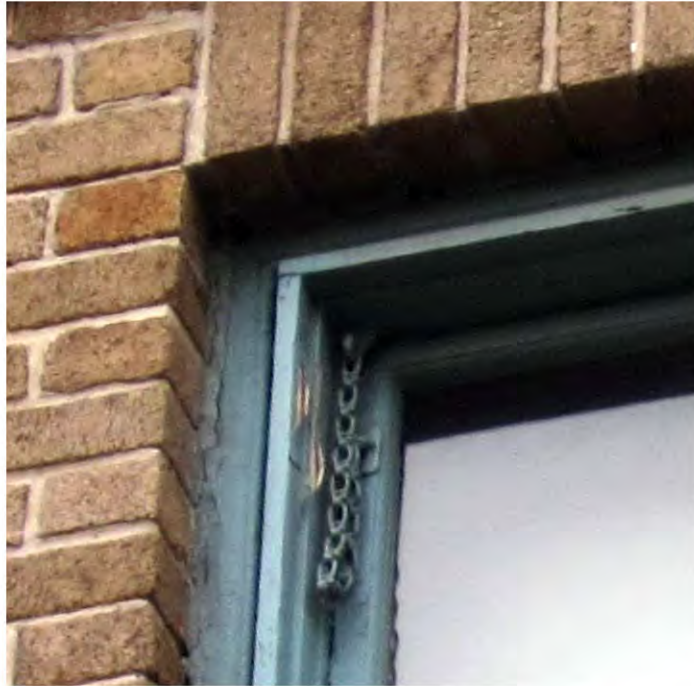
5

Typical condition of painted sash chains in 2016.

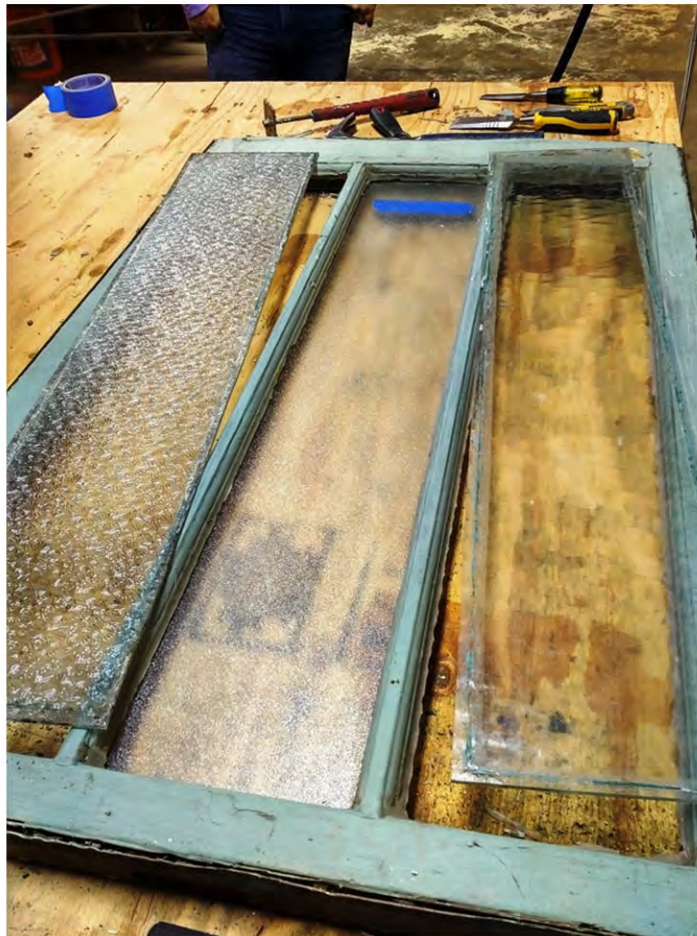
6

Typical condition of lavatory hopper windows in 2016.

With regard to the lavatory windows, which had several different types of obscuring glass, the decision was to rehabilitate the wood sash, repaint to match the upper windows on the exterior (the interior paint was matched to the existing green trim color), and install glass to match the earliest type of glass found in the windows.

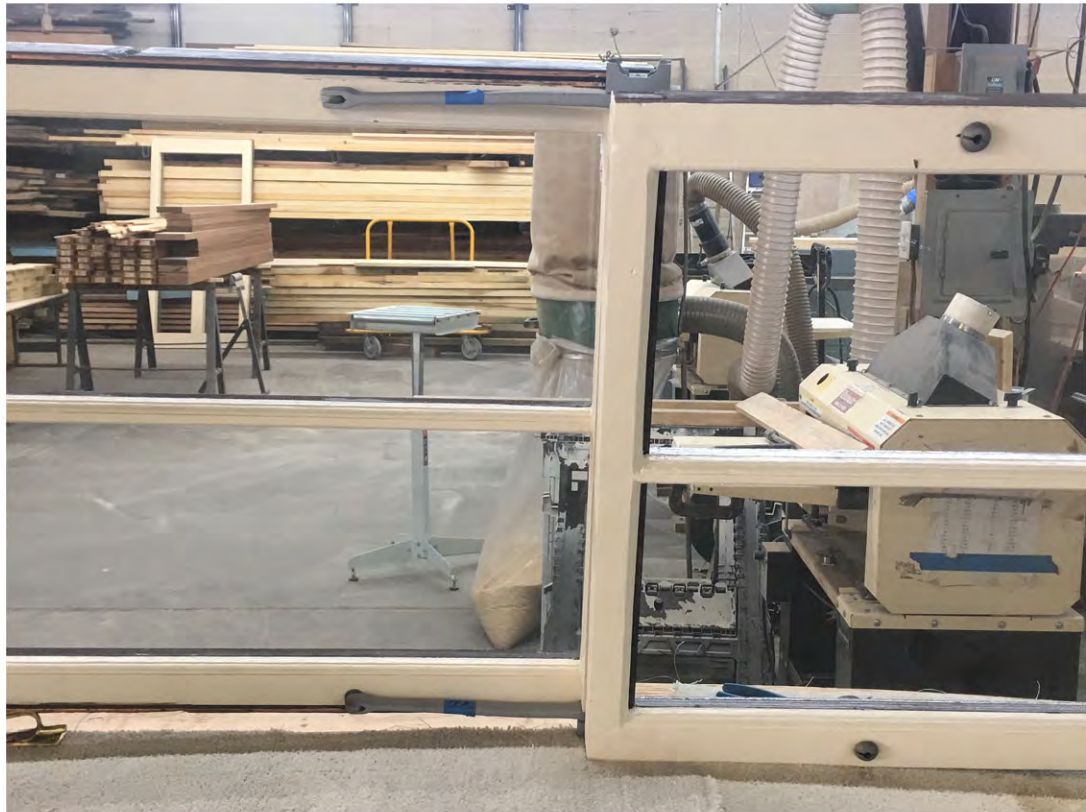
7

Partially restored Austral window assembly at Dell-Tech studio (2018).

Given the amount of deterioration and the proposed rehabilitation not only of the wood sash, but also the need to refurbish the hardware to make the units operable, the sashes were all removed from the openings and transported to the contractor's shop in Trenton. There, the glazing was carefully removed and numbered by position in the sash, the putty scraped, the paint was removed carefully as per the specifications and primed, awaiting selection of the appropriate color by MDKA, in consultation with the Library Director and the MHPC. Plywood panels were installed to cover the empty window openings during the work.

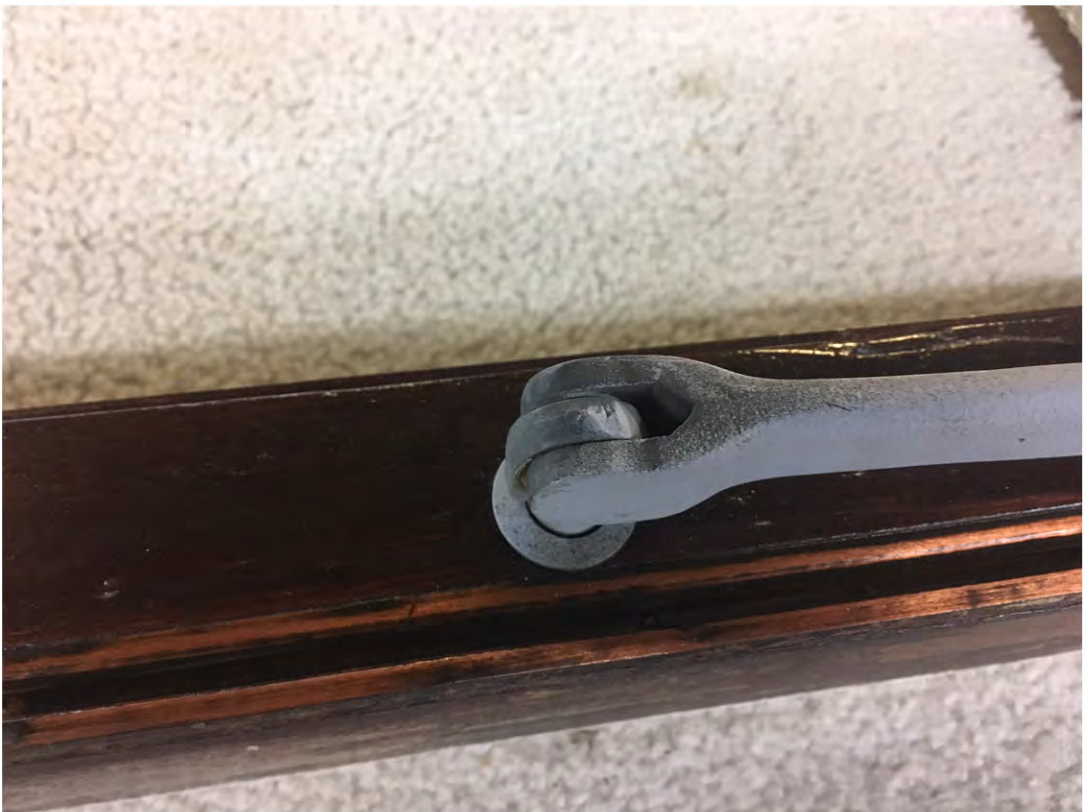
8

Detail of cleaned and primed lever arm and eye of thru-bolt at Dell-Tech Studio (2018).

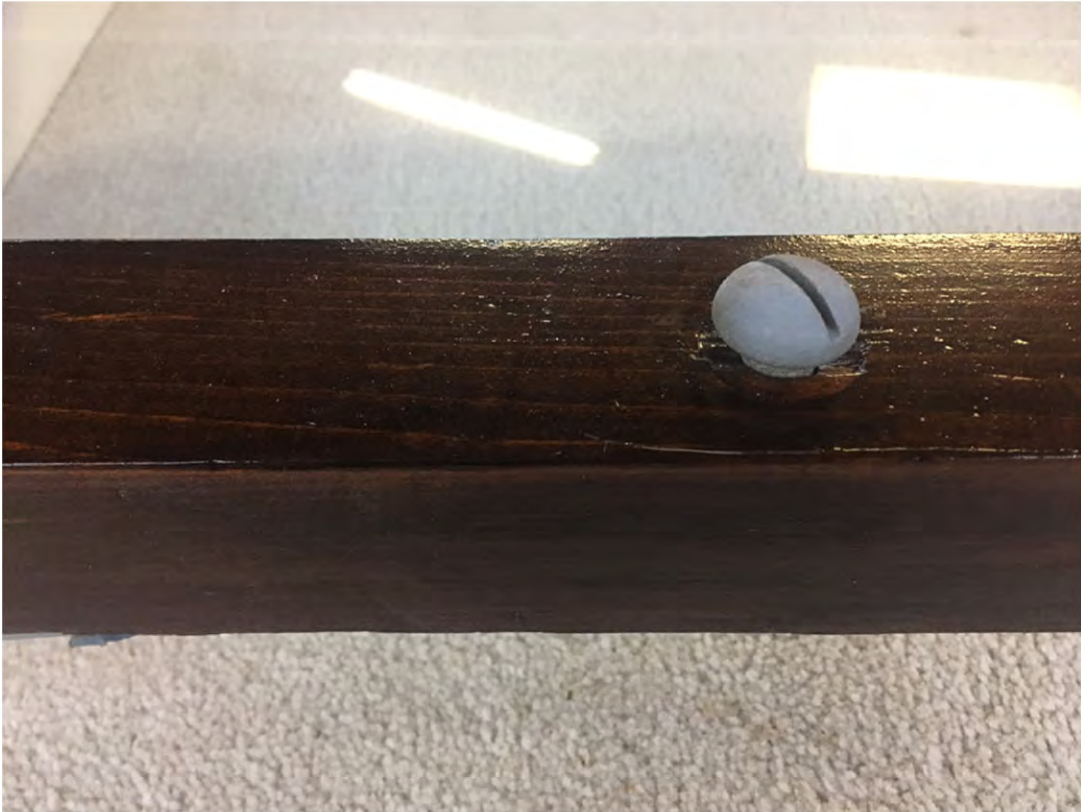
**9**

Detail of thru-bolt that holds the lever arms to the sash (at Dell-Tech studio, 2018).

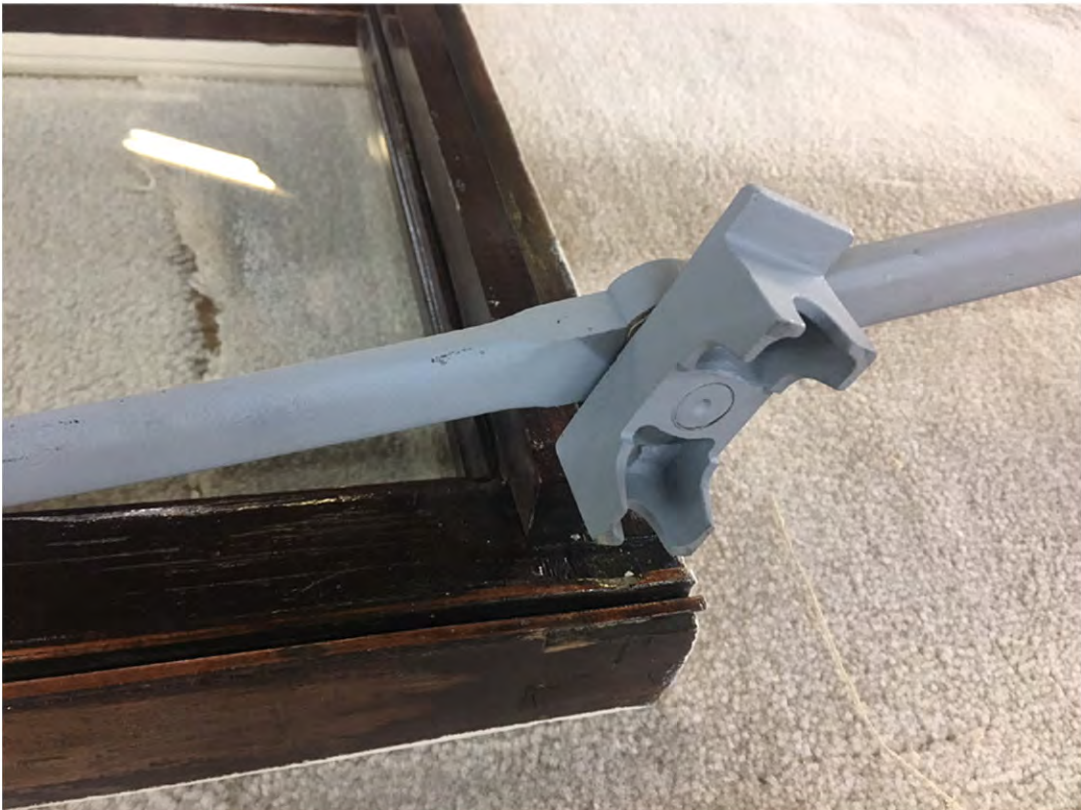
**10**

Detail of cleaned and primed bracket on lever arm for mounting onto jamb (at Dell-Tech Studio, 2018).

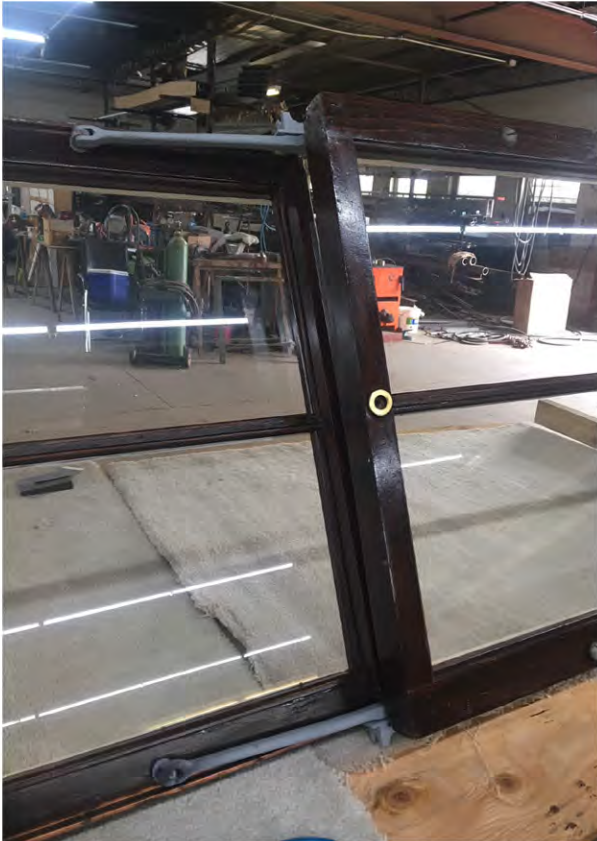
**11**

Detail of interior of Austral window assembly, with upper sash at left, lower sash at right, with restored brass grommet around hole for the hook that operates window movement (at Dell-Tech studio, 2018).

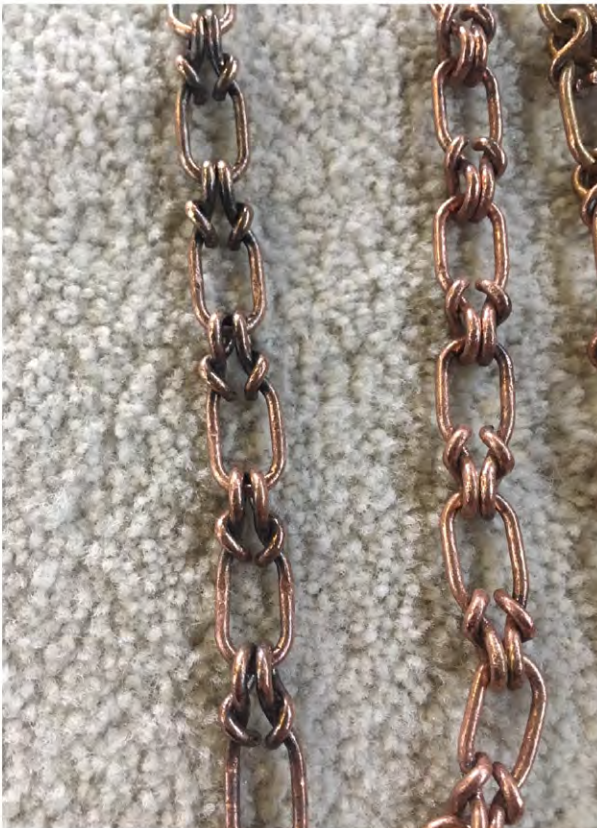
**12**

Detail of cleaned original "weldless" sash chains (at Dell-Tech Studio, 2018).

Additional hardware items included a “**weldless sash chains,**” two per window, that were affixed to the transom sash and held it in position when open. The original chains, after cleaning, appeared to have been fabricated of copper and electroplated with brass (see Appendix C: Photo 12). Where they still existed, they appeared to be generally in good condition, but had been painted with the sashes in the past, had become stiffened by the paint, and no longer swung freely. The chains for several of the windows were missing and had to be replaced (see Appendix E: Materials and Components). No exact replica of the historic chains could be found, so they were matched as closely as possible with a similar chain, and were grouped together on the east façade (see Appendix E: Materials and Components, Drawings W-3, W-4, and W-5, windows 14H, 15H, and 16H), the difference being less noticeable when all were the same (see Appendix C: Photos 17 and 18).

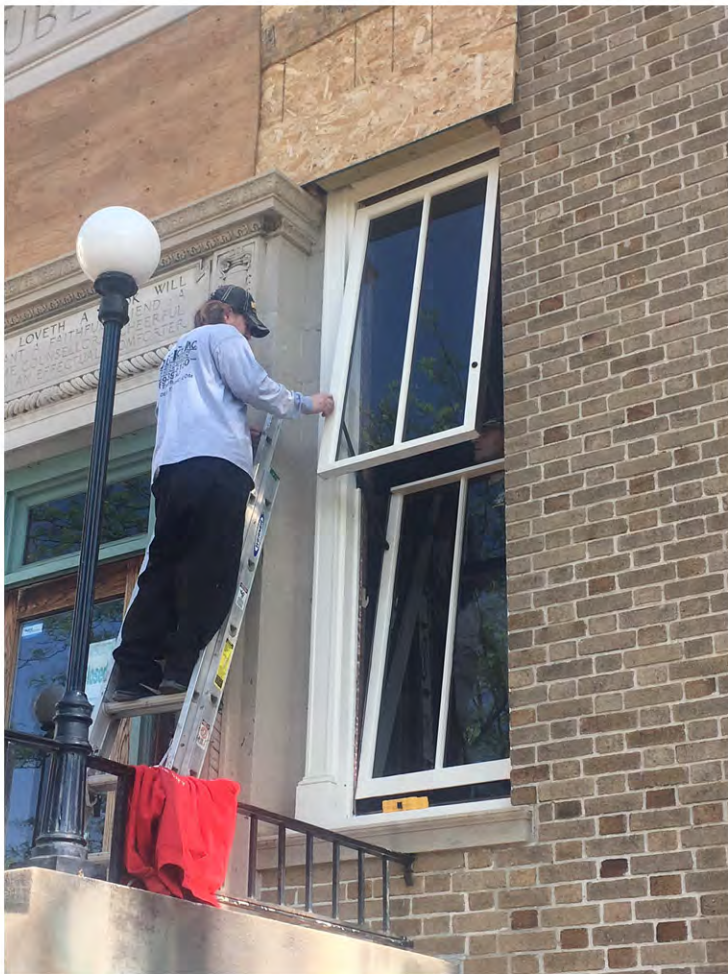
**13**

Test installation of rehabilitated Austral window on main facade (May 2018).

Comparison was made of the various types, research was conducted as to the possible era closest to original construction, and a likely candidate was selected: a flower pattern (see Appendix C: Photo 21). The more contemporary glazing was removed and replaced with the selected pattern of the obscuring glass. The sash was painted on the interior and exterior; the sash chains and other hardware were cleaned and reinstalled as were the windows on the upper floor, and the windows reinstalled in their original locations (see Appendix C: Photo 13, 14, and 22).

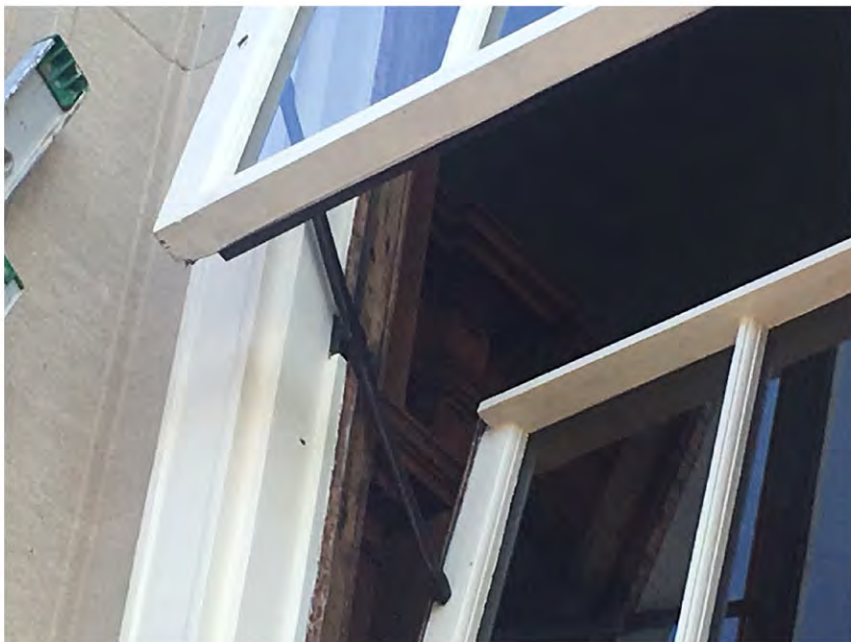
**14**

Test operation of Austral windows (May 2018).

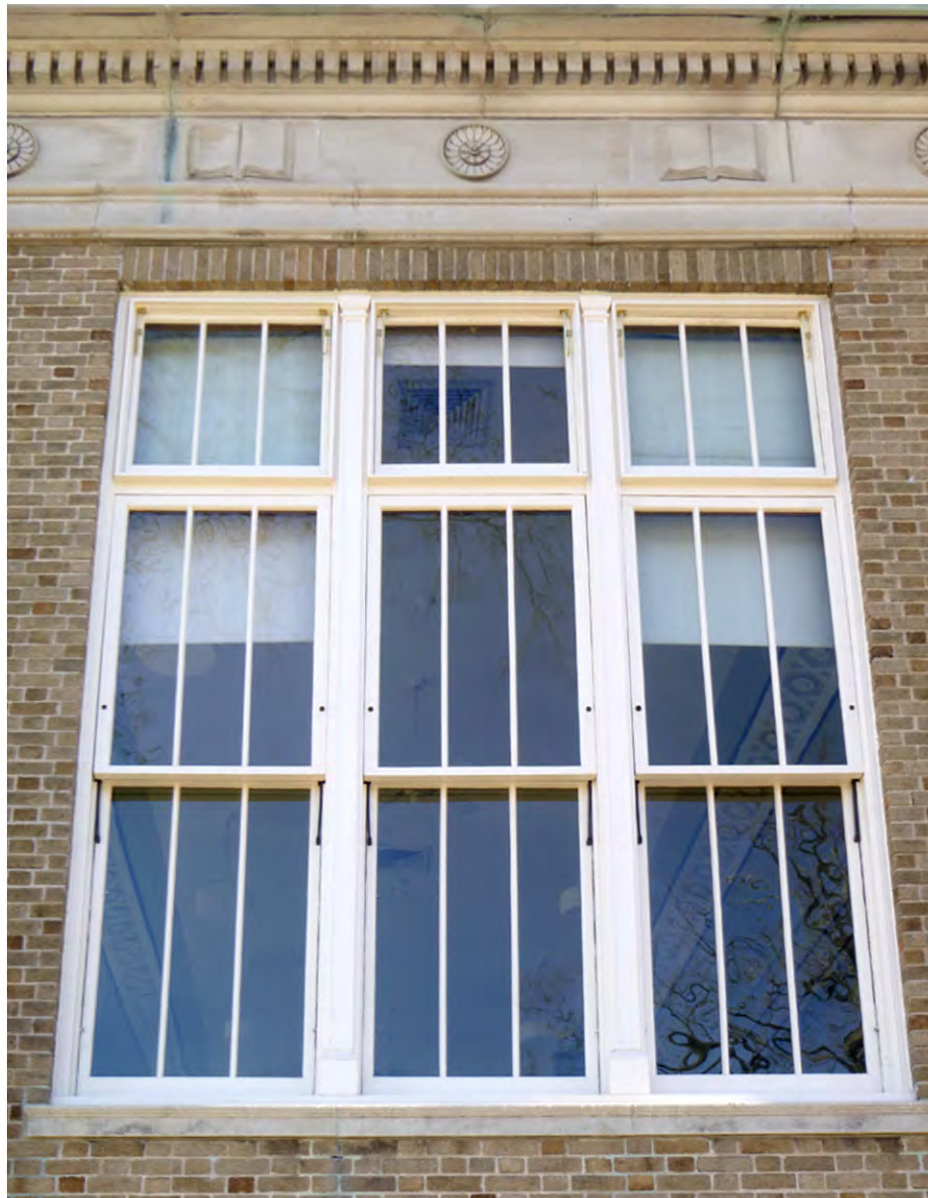
**16**

Fully restored Austral windows after installation, east facade (August 2018).

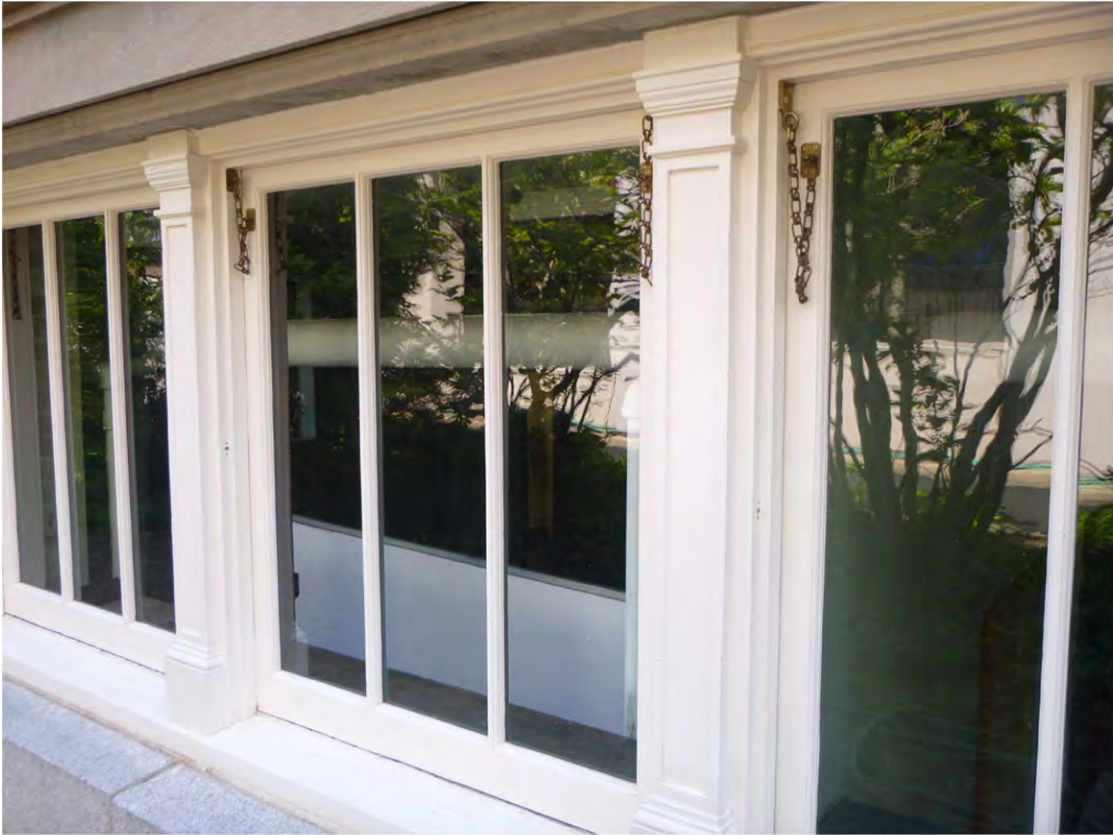
**17**

Restored hopper windows with original chains at the lower level children's room, looking SW (August 2018)

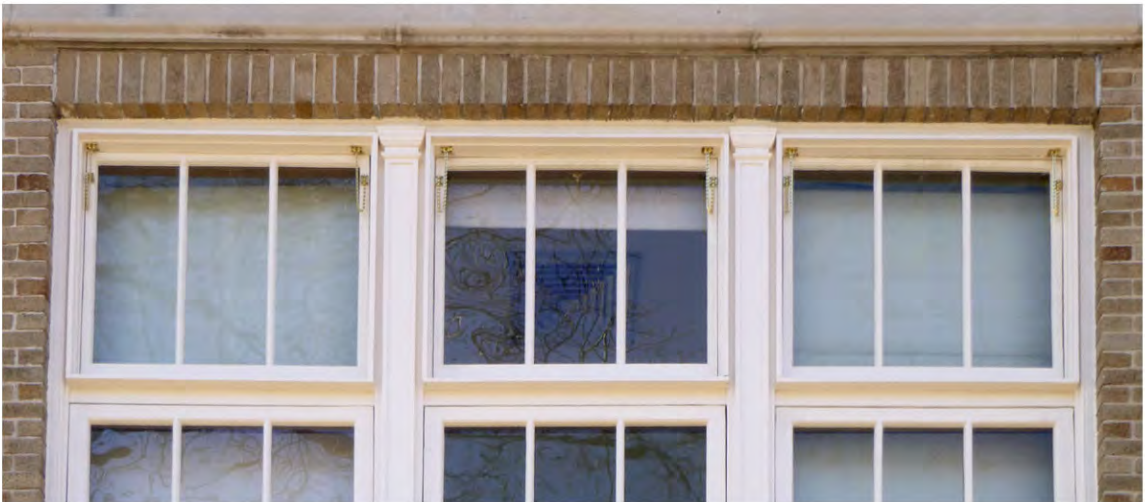
**18**

Restored transom windows with replacement chains after installation, east facade (August 2018).

4. Hopper Window Chains
  - a. There were a few hopper window chains there were either damaged or missing when the windows were taken from the library. Due to their unique design we were unable to find an exact match. Three sets of window chains (two per window) were sourced that match original design. These chains were grouped together on windows 14H, 15H, and 16H.

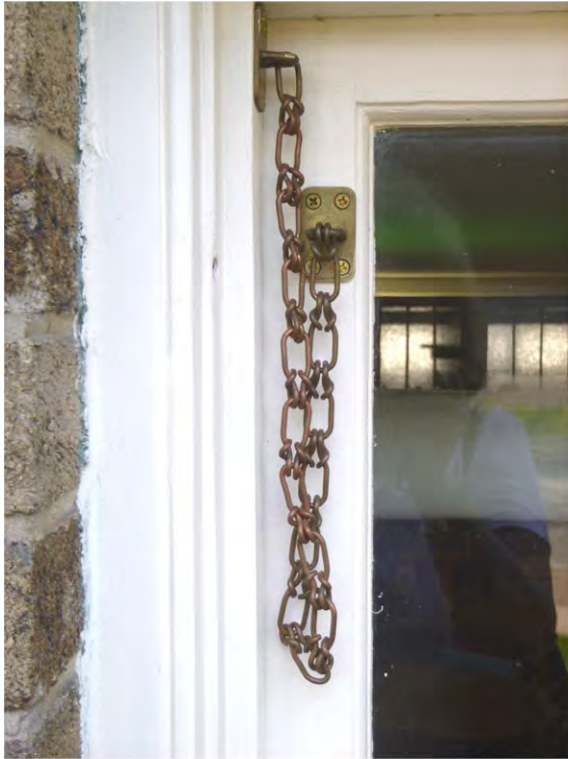
**19**

Detail of restored original "weldless" chain on re-installed hopper windows at the lower level children's room, looking W (August 2018).

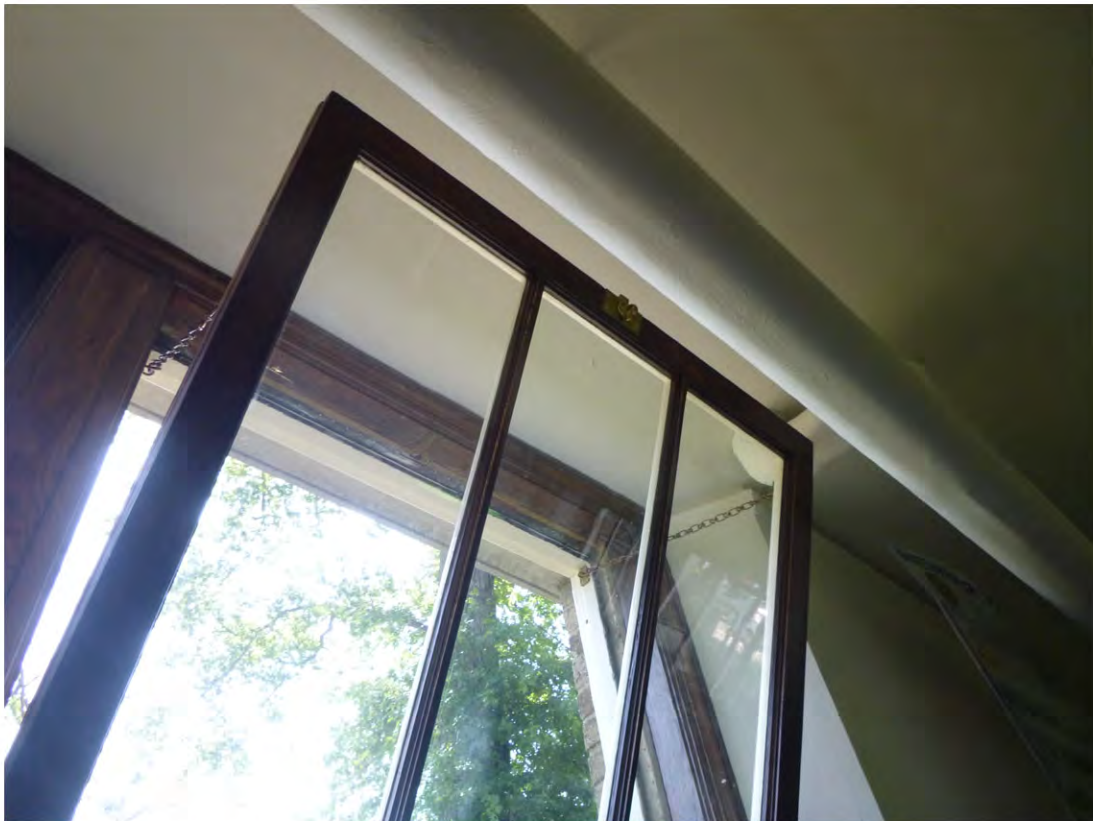
**20**

Restored hopper window held in open position by sash chain, east facade (August 2018).

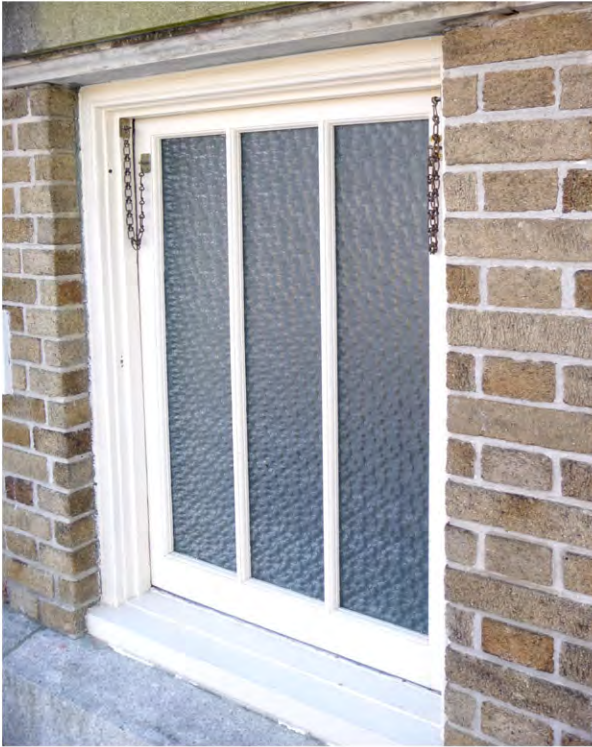
**21**

Restored hopper window with replacement obscuring glass, lower level lavatory, looking NE (August 2018).

2. Window Glass
  - a. Bathroom Privacy Glass: Over time, the library replaced multiple pieces of privacy glass in both bathrooms. It was determined that one type of glass originated from the original construction of the building and more of this type was sourced. This sourced glass and the original glass were used to have matching panes throughout all bathroom windows.

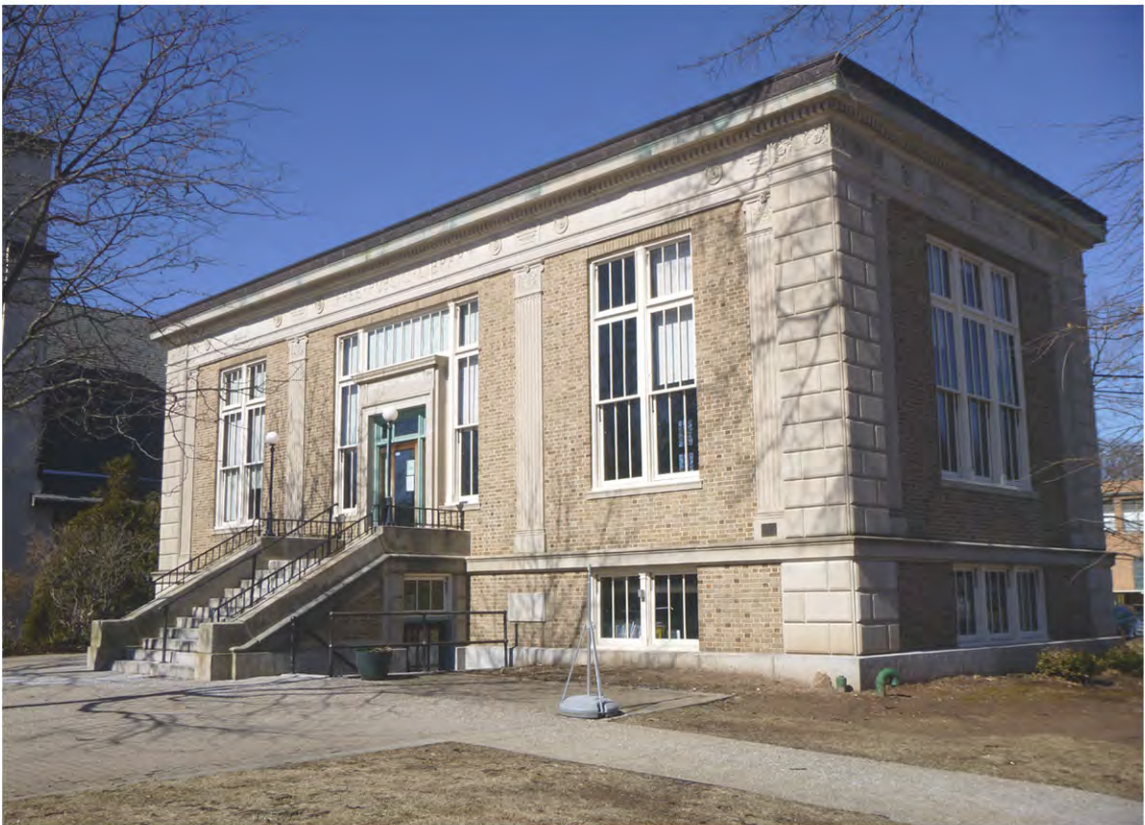
**22**

The completed window rehabilitation project in February 2019.

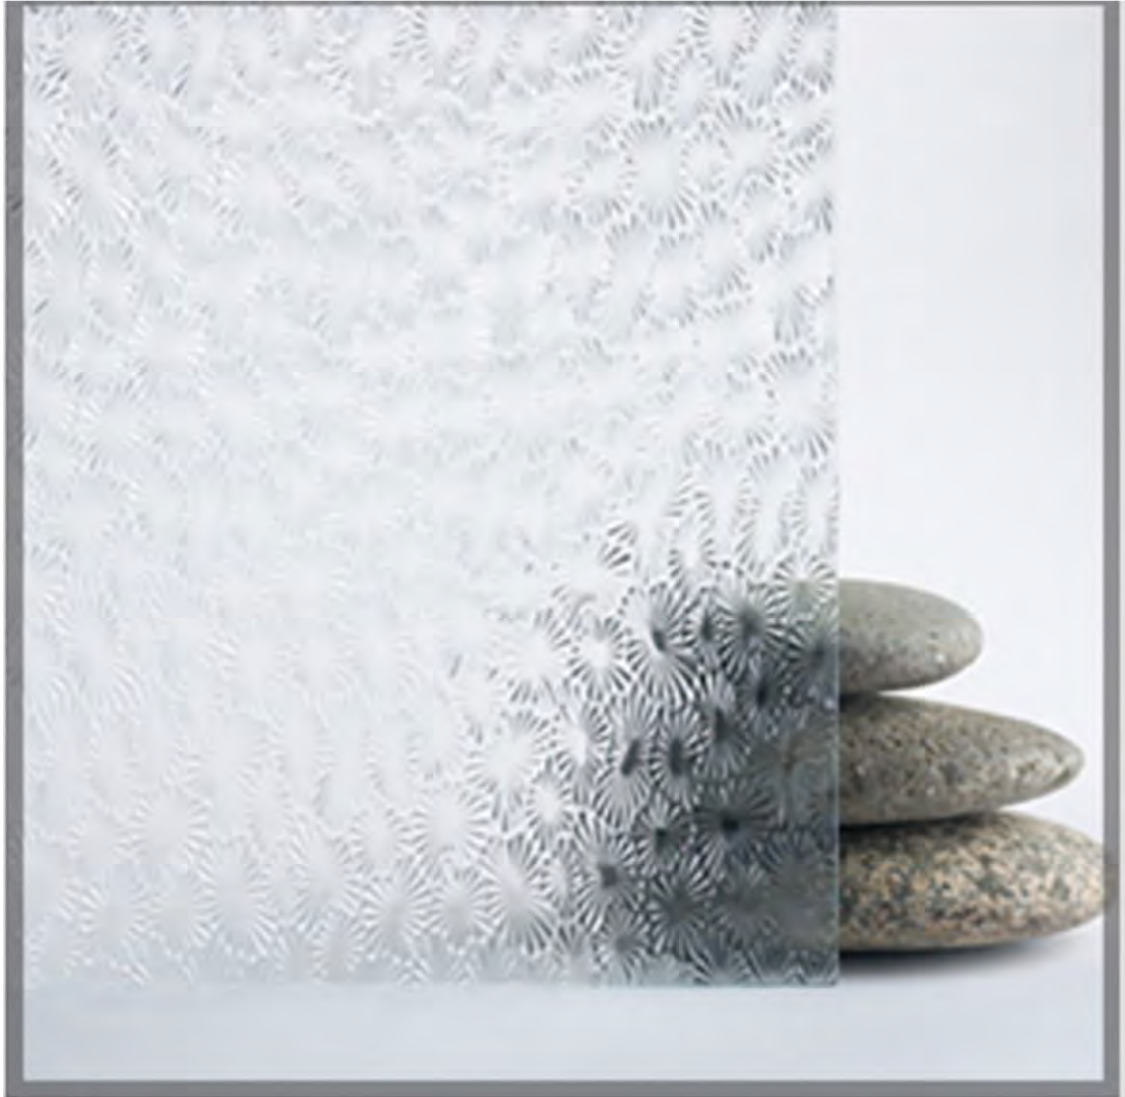
Manufacturer's image of floral patterned obscuring glass (2018). This pattern was selected to replace the three types of more contemporary "privacy glass" that were installed in various places in the lower level hopper windows.
